# Inspection Report

**Property Address:**  
1 Elm Street  
Centerville, GA 31047

**Ace Home Inspection, LLC**

<b>Date:</b> 3/1/2005	<b>Time:</b> 09:42 AM	<b>Report ID:</b> 111111
<b>Property:</b> 1 Elm Street Centerville, GA 31047	<b>Customer:</b> Mr. Samuel Smith Mrs. Meg Smith	<b>Real Estate Professional:</b>

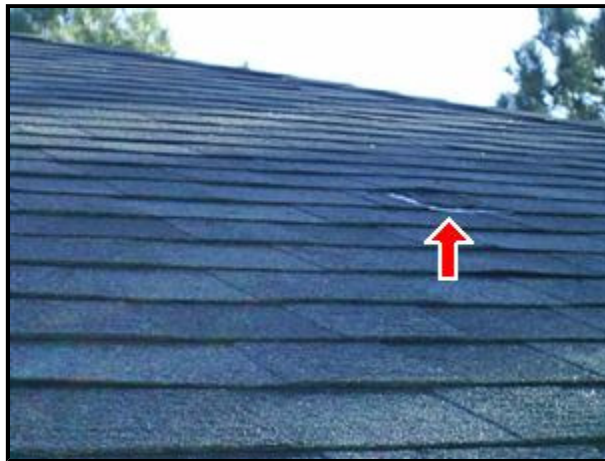
- 📌 **1.0** Asphalt deteriorating, right rear of home. Recommend evaluation by a qualified roofing contractor.

1.0 Picture 1 Deteriorating asphalt shingle

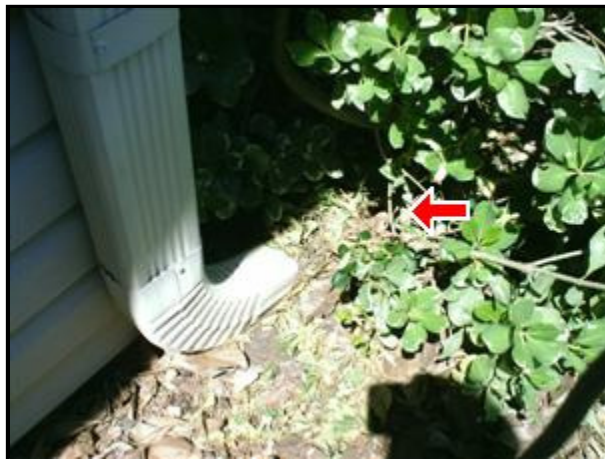
- 📌 **1.3** Gutter downspout located left front of home requires an extension to move water away from foundation.

1.3 Picture 1 Downspout left front of home

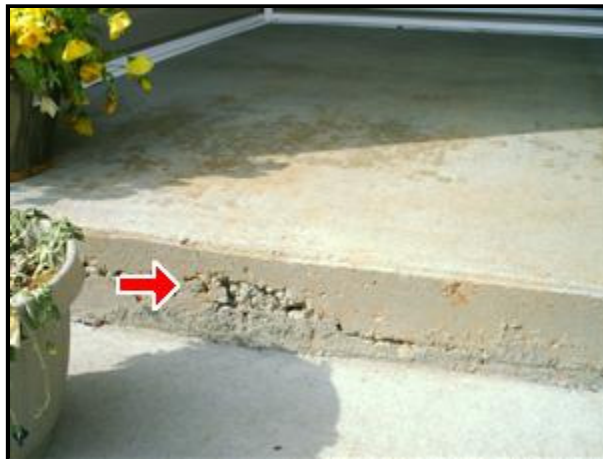
**2.3** Concrete porch has large vacancies on front face. Recommend filling in with concrete to prevent water intrusion and future deterioration. Contact qualified concrete contractor for further evaluation and repairs.

2.3 Picture 1 Front porch

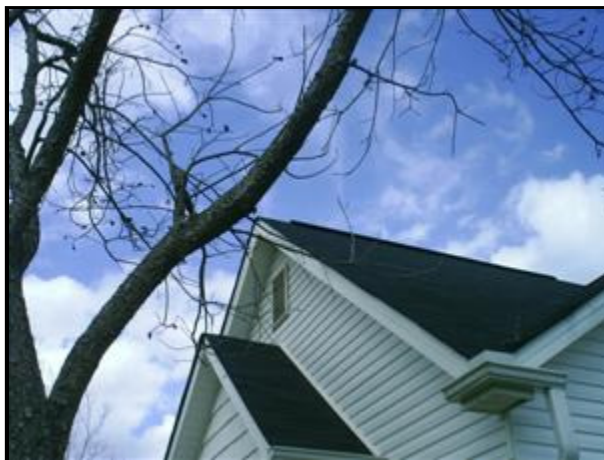
**2.4** Recommend removal of large limb overhanging right side of home.

2.4 Picture 1 Limb overhanging roof.

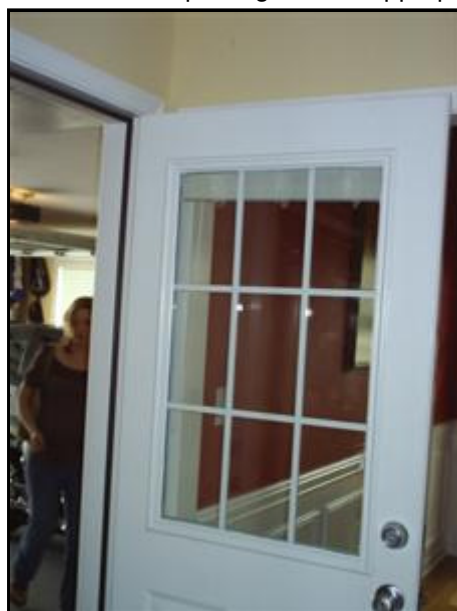
**3.4** This is not a fire rated door. Recommend replacing with an appropriately rated door.

3.4 Picture 1 Garage to dwelling door.

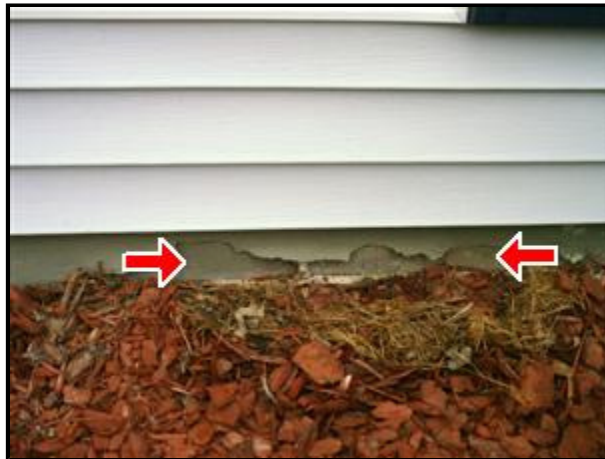
**5.0** Protective water seal on foundation of front of home is crumbling away. Recommend evaluation and repairs to prevent water intrusion by a qualified contractor.

5.0 Picture 1 Water barrier, front of home

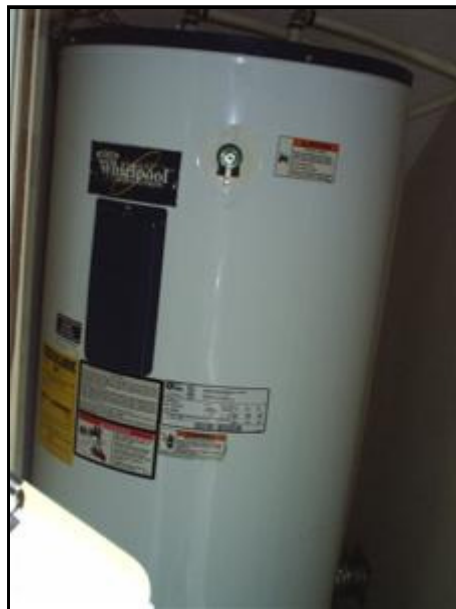
**6.2** Condensation tube is missing from hot water heater. Recommend evaluation and repairs by a qualified plumber.

6.2 Picture 1 Water heater located in garage

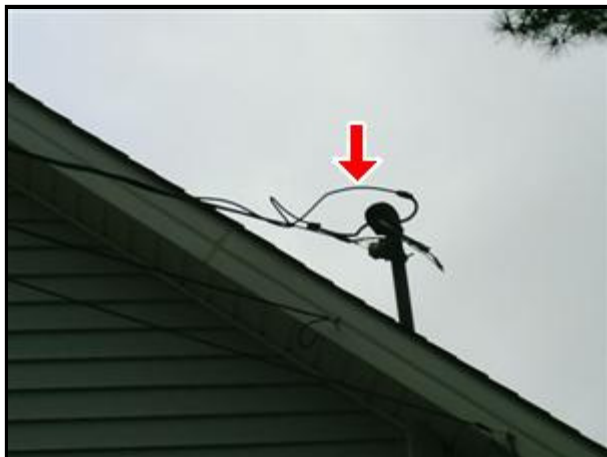
**7.0** Electrical service entrance to chase way does not have drip loop. Recommend repairs by electric company.(Picture 1)

7.0 Picture 1 Electrical service entrance.

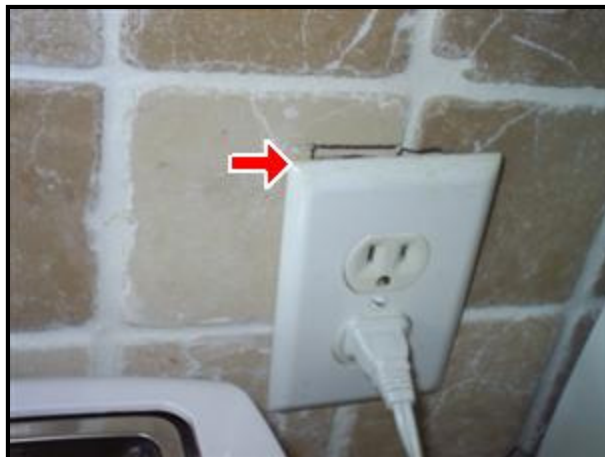
- 7.3** Electrical outlet in kitchen is loose. Recommend repairs by a qualified electrician.

7.3 Picture 1 Kitchen outlet

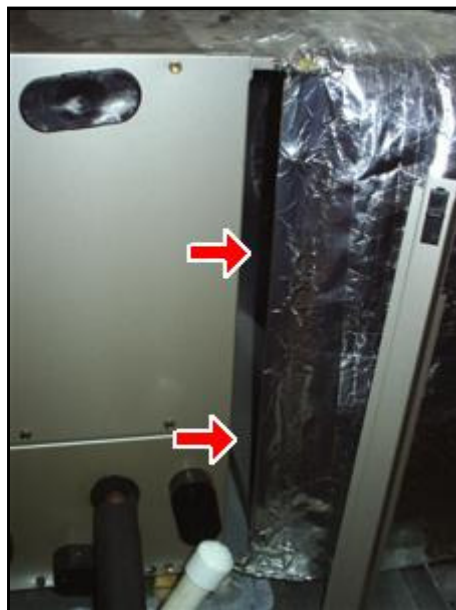
**8.0** No filter present in heat pump. Recommend installing appropriate filter.

8.0 Picture 1 Heat pump attic

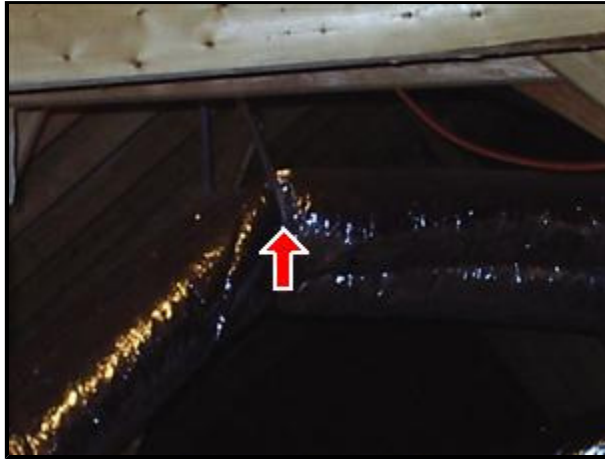
**8.3** Ductwork in attic pinched by suspension strap. Recommend evaluation and repairs by a qualified HVAC technician.

8.3 Picture 1 Ductwork

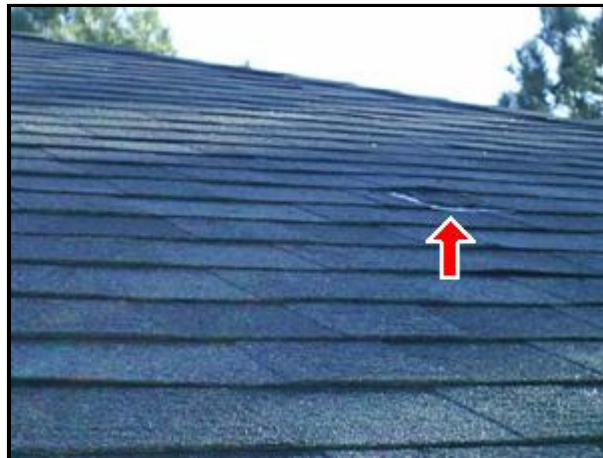
Asphalt deteriorating, right rear of home. Recommend evaluation by a qualified roofing contractor.

1.0 Picture 1 Deteriorating asphalt shingle

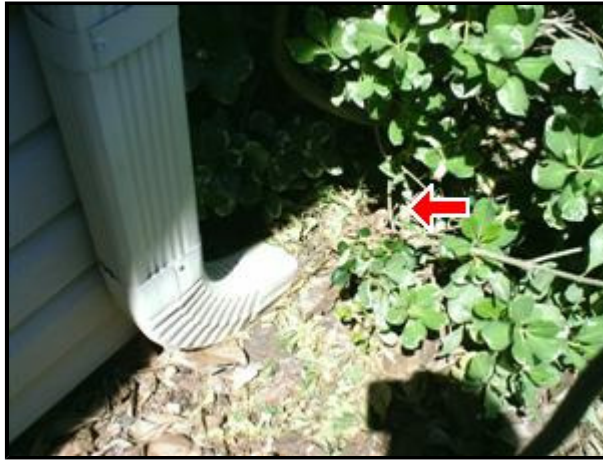
Gutter downspout located left front of home requires an extension to move water away from foundation.

1.3 Picture 1 Downspout left front of home

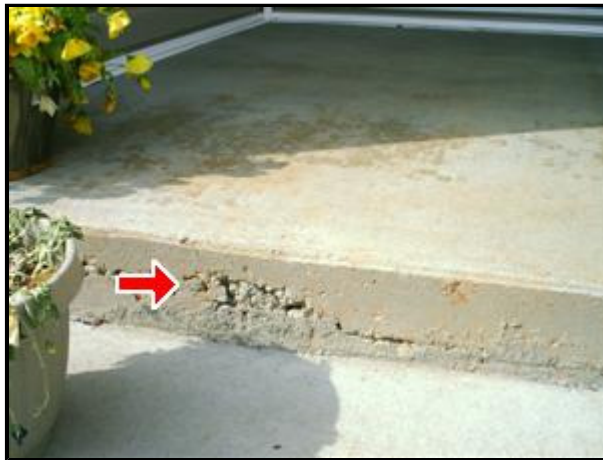
Concrete porch has large vacancies on front face. Recommend filling in with concrete to prevent water intrusion and future deterioration. Contact qualified concrete contractor for further evaluation and repairs.

2.3 Picture 1 Front porch

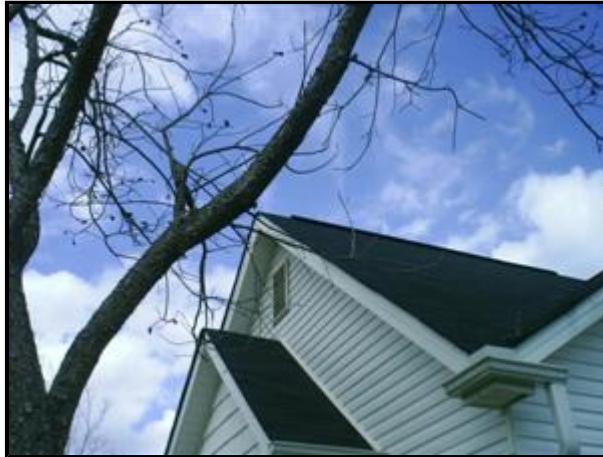
Recommend removal of large limb overhanging right side of home.

2.4 Picture 1 Limb overhanging roof.

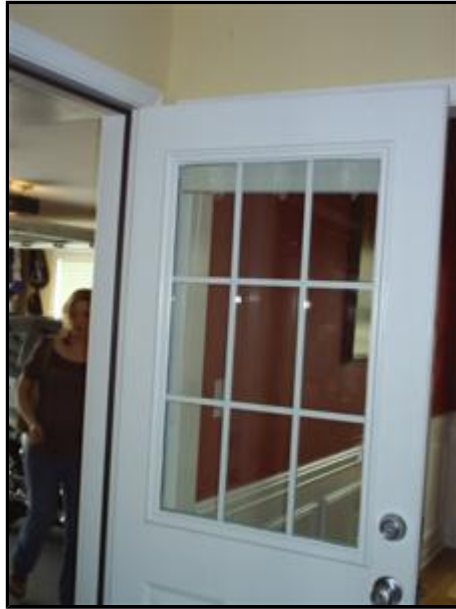
This is not a fire rated door. Recommend replacing with an appropriately rated door.

3.4 Picture 1 Garage to dwelling door.

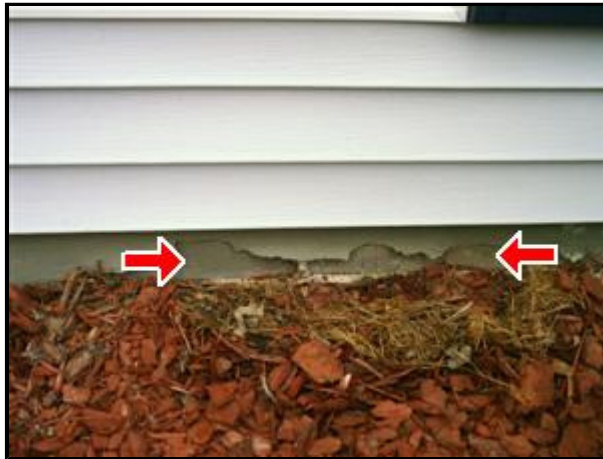
Protective water seal on foundation of front of home is crumbling away. Recommend evaluation and repairs to prevent water intrusion by a qualified contractor.

5.0 Picture 1 Water barrier, front of home

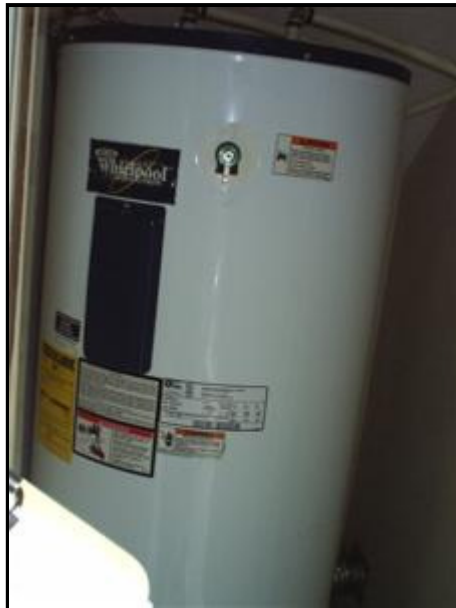
- Condensation tube is missing from hot water heater. Recommend evaluation and repairs by a qualified plumber.

6.2 Picture 1 Water heater located in garage

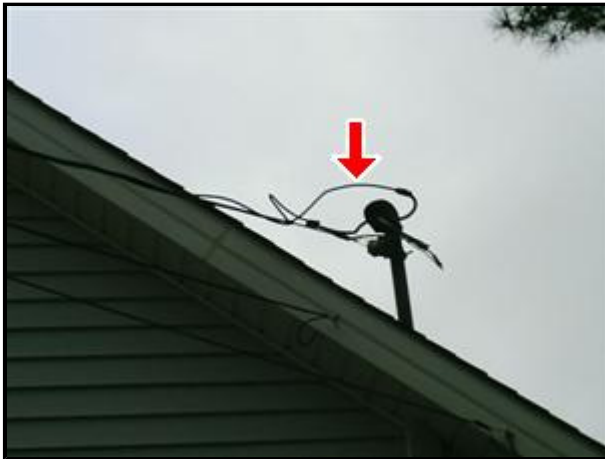
- Electrical service entrance to chase way does not have drip loop. Recommend repairs by electric company.(Picture 1)

7.0 Picture 1 Electrical service entrance.

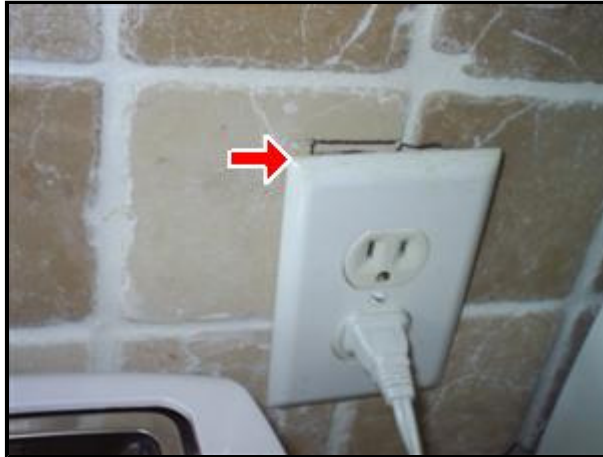
- 🏠 Electrical outlet in kitchen is loose. Recommend repairs by a qualified electrician.

7.3 Picture 1 Kitchen outlet

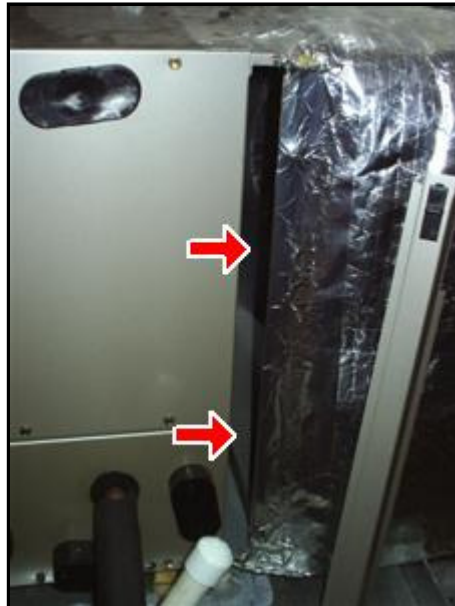
No filter present in heat pump. Recommend installing appropriate filter.

8.0 Picture 1 Heat pump attic

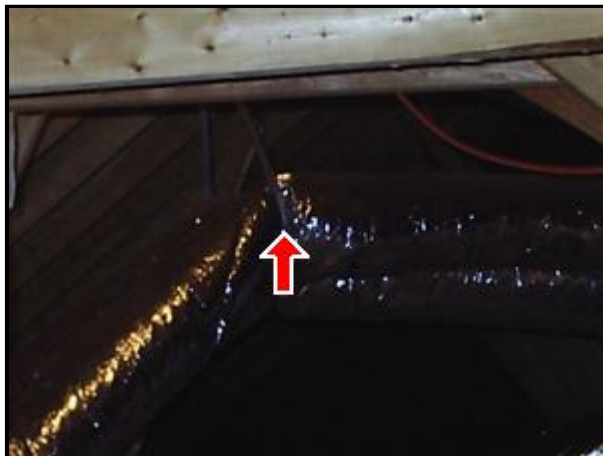
Ductwork in attic pinched by suspension strap. Recommend evaluation and repairs by a qualified HVAC technician.

8.3 Picture 1 Ductwork
